## NASA Contractor Report 165664

# Advanced Composite Aileron For L-1011 Transport Aircraft-- Ground Tests And Flight Evaluation

**C.F. Griffin**

GROUND TESTS AND FLIGHT EVALUATION

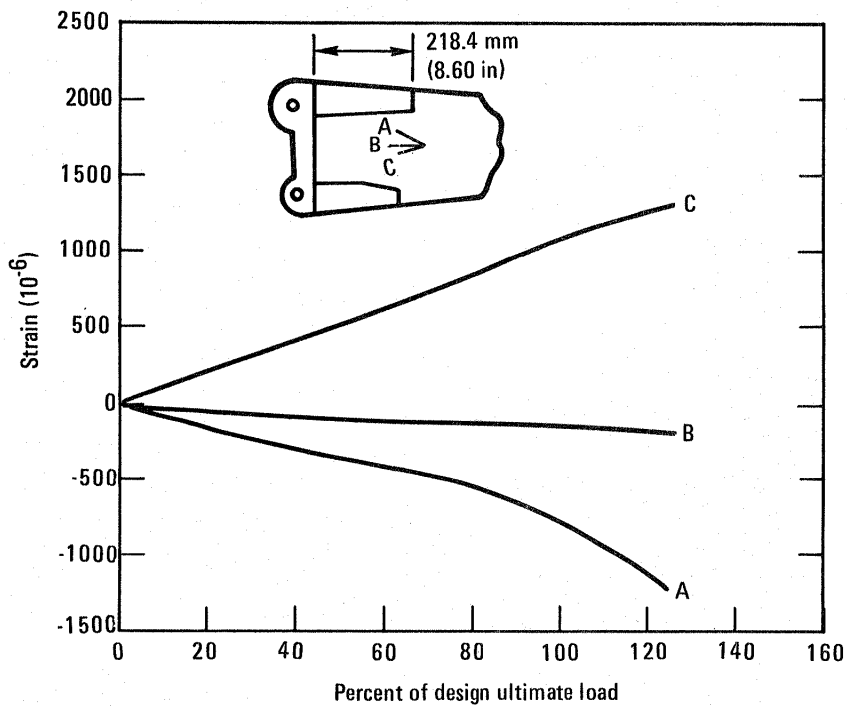
Figure 19. - Condition 4, I.A.S. 102.7 rib web strains at page 24.

The back-to-back strain rosette data for the hinge/actuator rib web at I.A.S. 102.7 are shown on figures 18 and 19. These rosettes, located 218.4 mm (8.6 in) aft of the front spar web, indicate the initiation of rib web buckling at 90 percent of DUL.

Following these tests the aileron was loaded to failure in the Condition 1 configuration. Failure occurred at 139 percent DUL. The lower cover was removed (figure 19) to permit examination of the failed members. Neither the covers nor the front spar experienced visible damage. The station 102.7

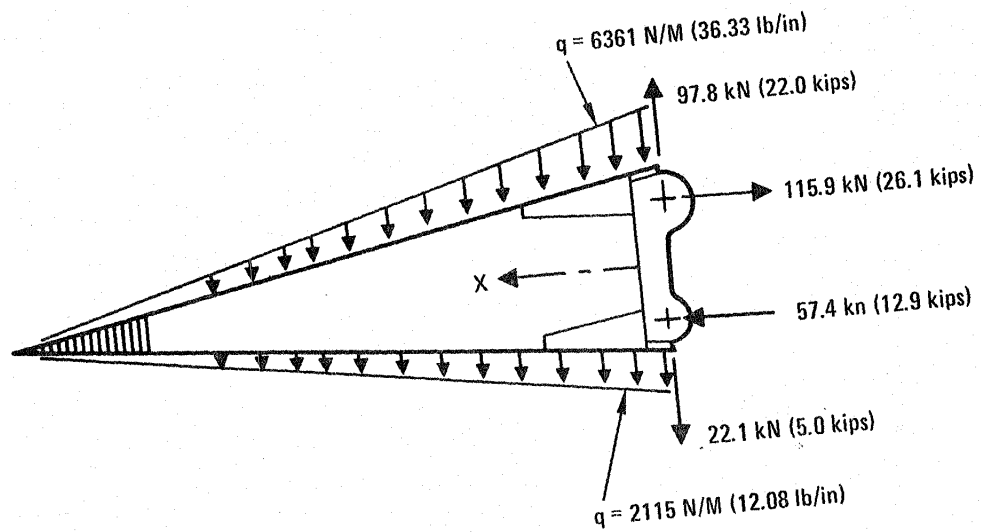
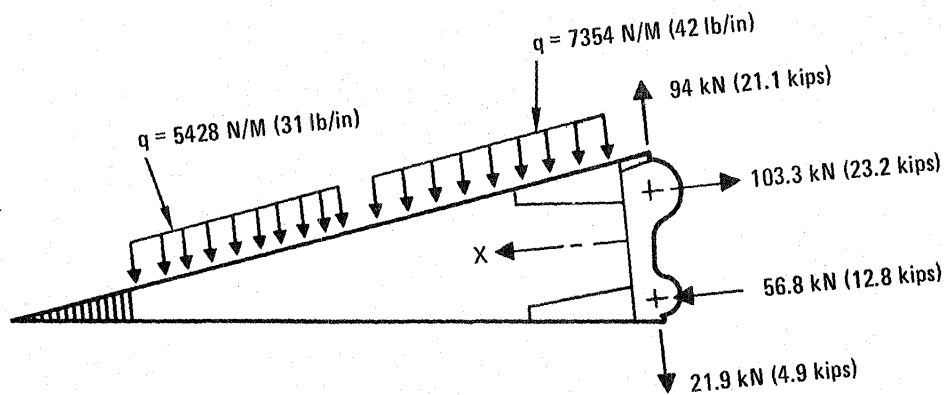
Figure 25. - Comparison of design loads to test loads for I.A.S. 102.7 rib.

As illustrated on figures 25 and 26 the results of the rib analysis show that the rib loads applied in the test were equivalent to those applied by the flight loading condition. Based on this analysis the predicted failure load for the rib web (using room temperature, dry average material properties) was 126 percent of design ultimate load.
